TECHNICAL NOTE

GLULAM CONNECTION DETAILS

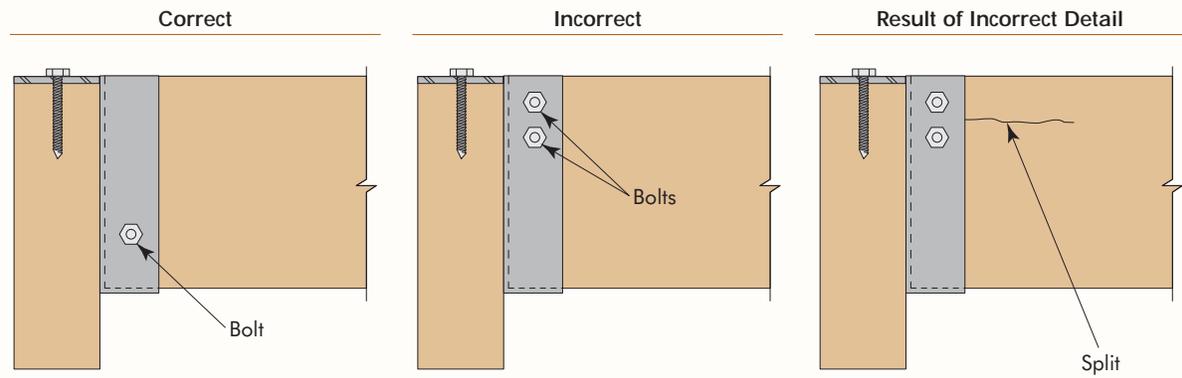
FIGURE 3C

Shrinkage of supported beam causes bearing load to transfer from beam saddle to bolts. This can cause splitting of beam.

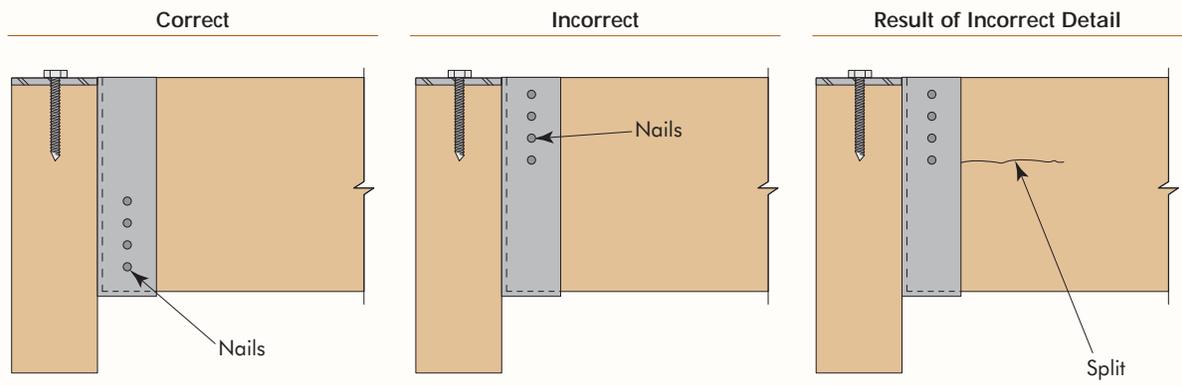
FIGURE 4

Shrinkage of supported beam causes bearing load to transfer from beam saddle to nail group. Even with nails, there is potential for splitting of beam.

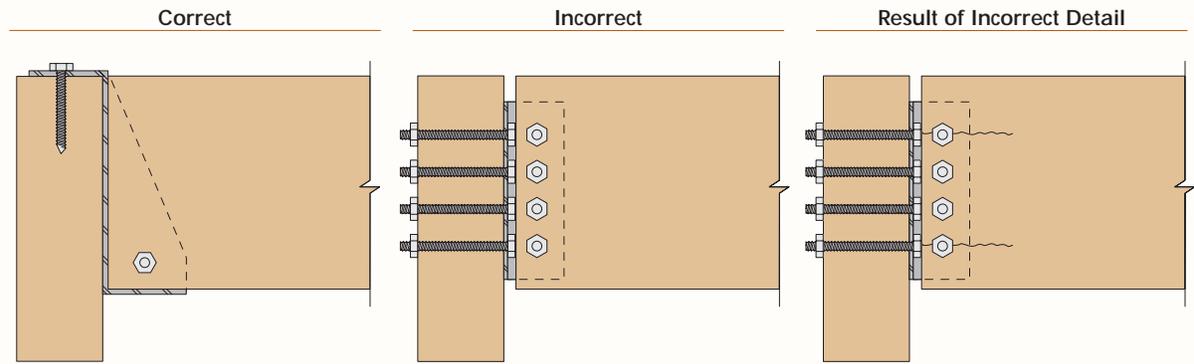
FIGURE 7
BEAM-TO-BEAM CONNECTIONS USING CONCEALED PLATES

Concealed plate with long row of fasteners can cause splits to form in suspended beam, as shown above. Use a concealed plate with bearing seat, as shown above left.

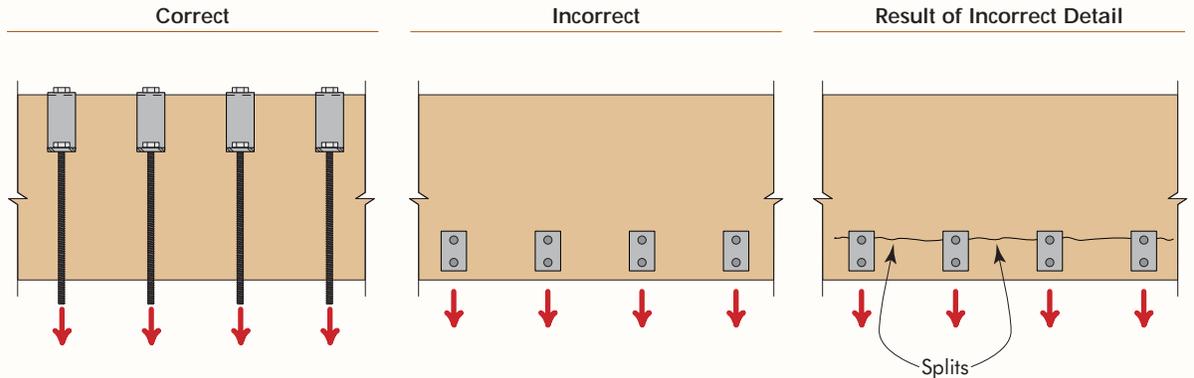
FIGURE 8
HEAVY CONCENTRATED LOADS SUSPENDED FROM BEAM

Heavy concentrated loads such as heating and air conditioning units, crane rails or main framing members suspended from the bottom of beams induce tension perpendicular-to-grain stresses and may cause splits as shown.

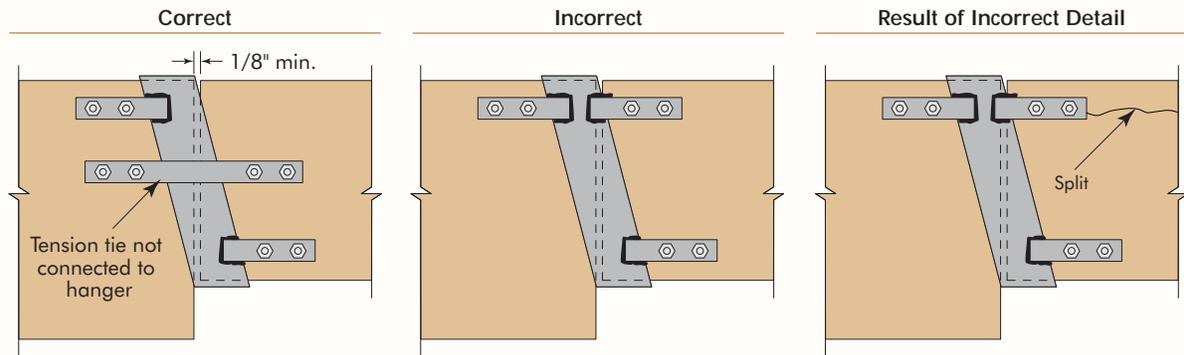
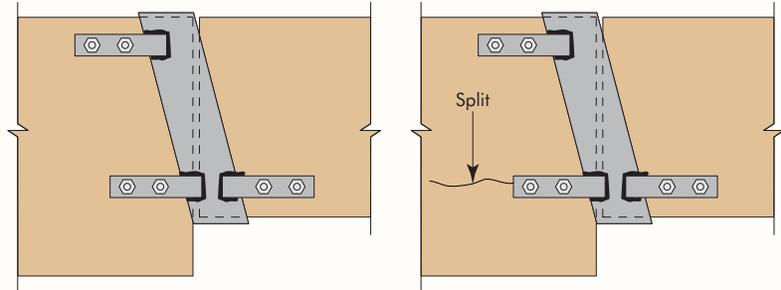
FIGURE 9
CANTILEVER BEAM CONNECTION – INDEPENDENT TENSION TIE

The relative vertical positioning of the side tabs shown in this detail is very important to minimize the possibility of splitting along the axis of these tabs due to beam shrinkage.

An integral tension-tie connection can cause tension perpendicular-to-grain stress to develop due to beam shrinkage. This can happen regardless of the location of the integral tension tie connector. If a tension connection is required, a separate connector may be used as shown in the upper left figure. This tie is not welded to the beam hanger.

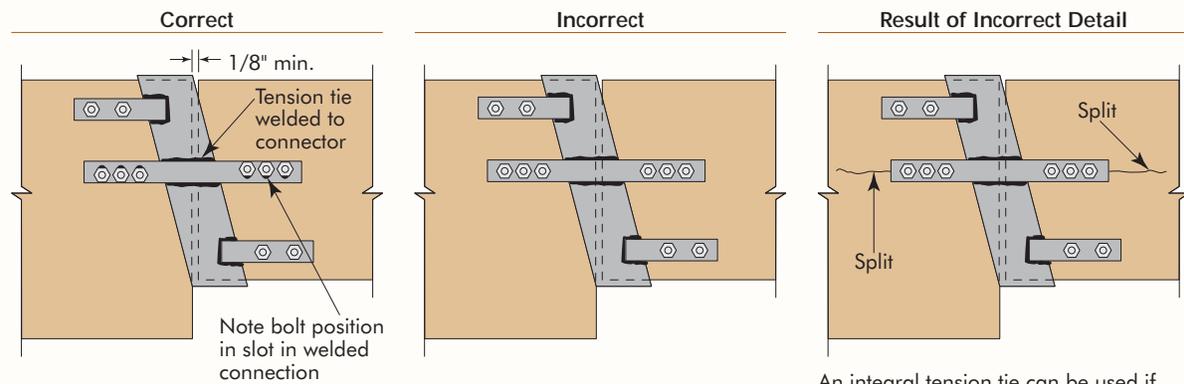
FIGURE 10

An integral tension tie can be used if holes in tie are vertically slotted and tie attachment bolts are placed, as shown, to allow motion of bolt in slot due to shrinkage of timber elements. If movement is not allowed at this location, tension perpendicular-to-grain stresses may develop in both members and cause splitting.

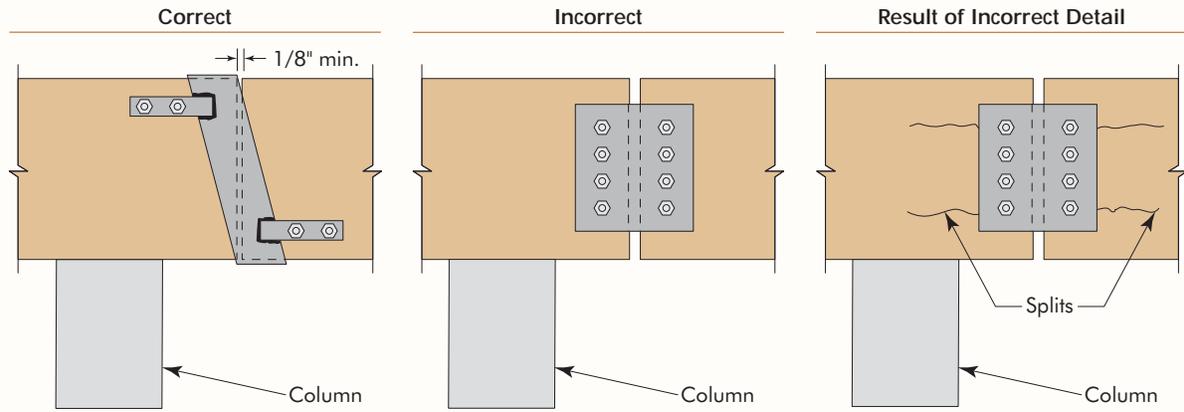
FIGURE 11A

Deep splice plates applied to both sides can cause splitting of both members if members shrink. Side-plates resist this shrinkage and may induce tension perpendicular-to-grain stresses which may in turn cause splits.

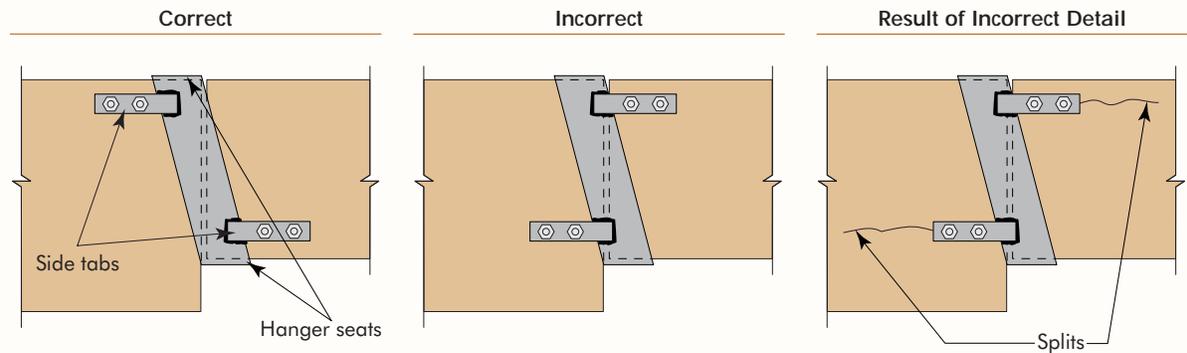
FIGURE 11B

With side tabs inverted, glulam beam shrinkage shifts load from hanger seats to side tabs. This is likely to induce tension perpendicular-to-grain stresses which can lead to the development of splits and beam failure.

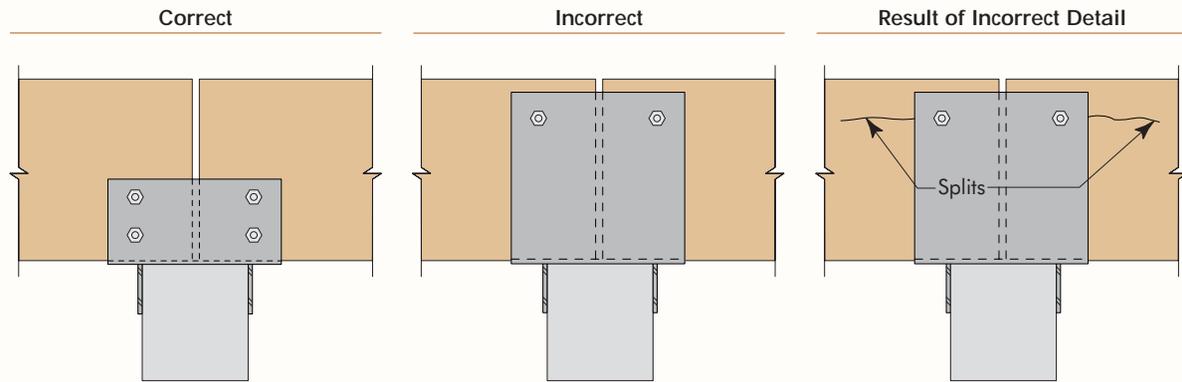
FIGURE 12A

If beam shrinks, bearing load may be transferred to bolts. This can cause splitting of beam. This detail also restrains beam rotation due to deflection under loading, which can also cause splitting.

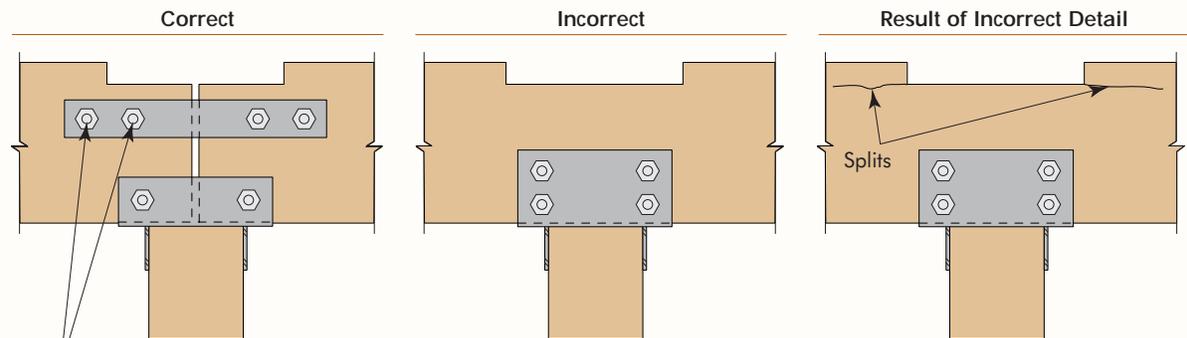
FIGURE 15

A notch in the top of a continuous beam over a center support occurs in the tension zone of the beam, greatly reducing its capacity. Design as two simply supported beams if top notch is required.

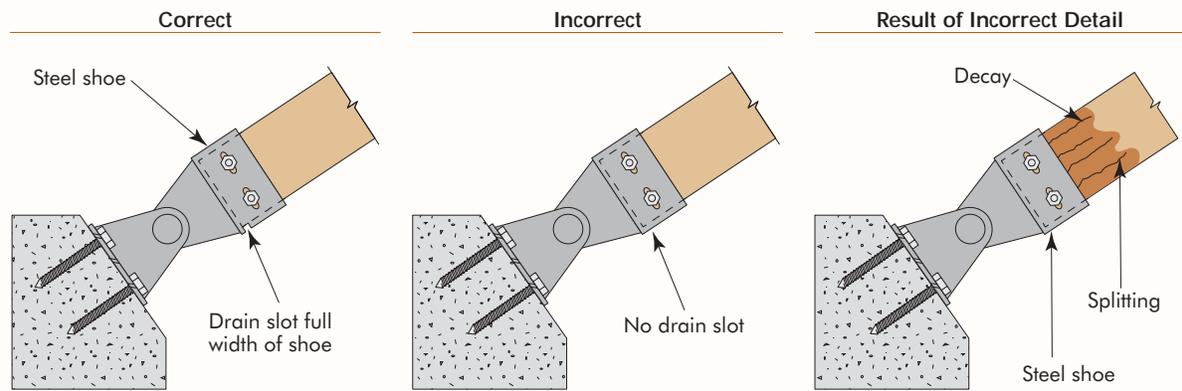
FIGURE 18

Steel arch shoe must be provided with drain slot to minimize moisture buildup which could result in decay. Interior bolts must be kept close together to prevent splitting if shrinkage occurs.

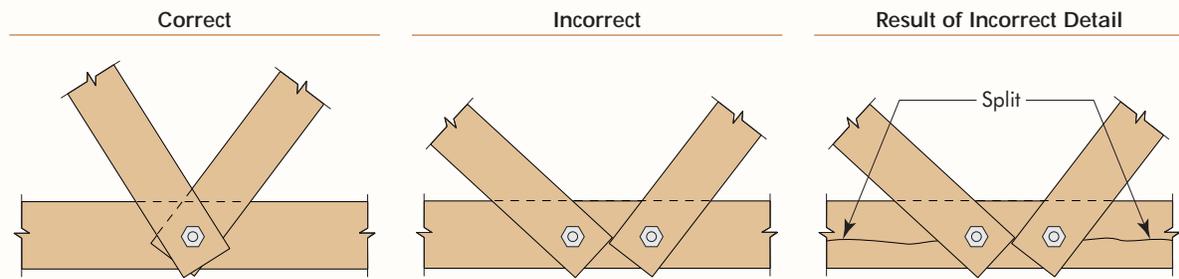
FIGURE 19A

Longitudinal axes of all three members do not intersect. This can induce shear, moment and tension perpendicular-to-grain stresses. A combination of the above stresses may induce a failure at the joint.

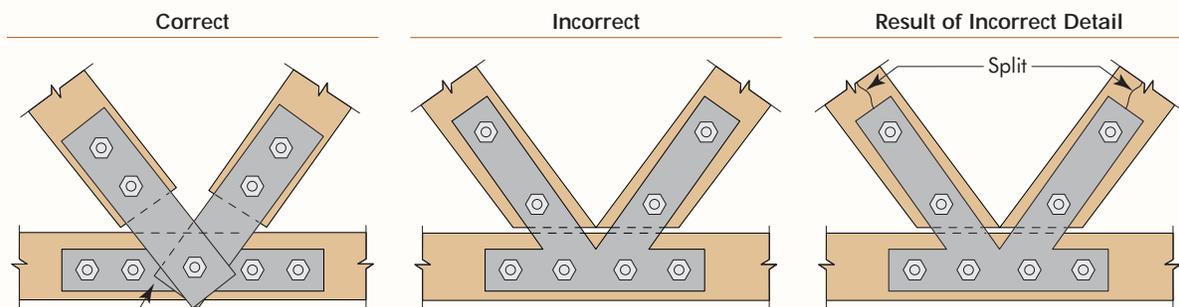
FIGURE 19B

Fixed-angle gusset plate does not let members rotate under load. This may induce moments in ends of members which can cause splitting of webs at bolt locations.

Design plate to withstand compression buckling

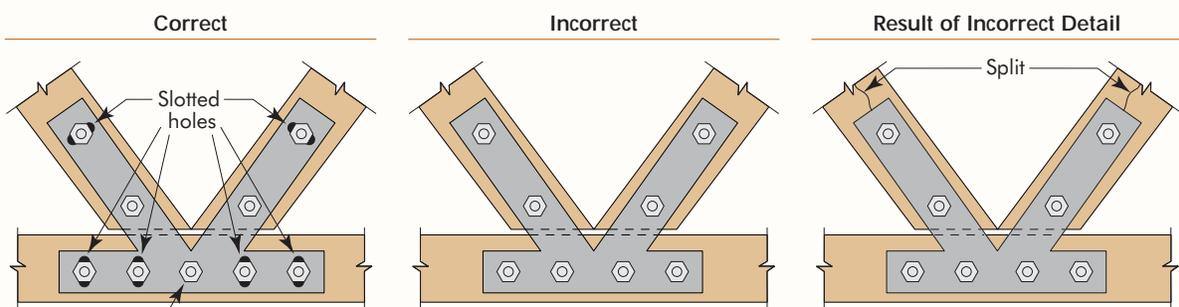
FIGURE 19C

Fixed-angle gusset plate does not let members rotate under load. This may induce moments in ends of members which can cause splitting of webs at bolt locations.

Center bolt to align with web axis intersection flange
